VEHICLE LEAN/SAG WHEN OBSERVED FROM REAR OF VEHICLE

TSB 04-23-6

1999-2005 F-250, F-350

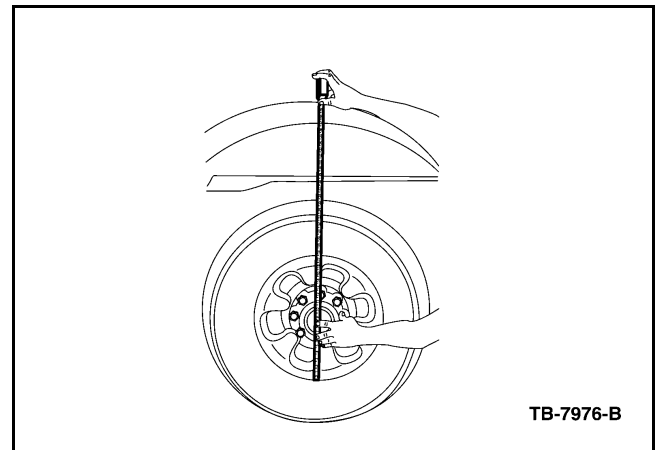
Figure 1 - Article 04-23-6

3. Measure the vehicle ride height from wheel lip to top of wheel well opening, at all four corners, Figure 1.
