**FORD:**

2004-2005 Excursion

2004-2006 F-Super Duty

## TSB 05-19-12 (Continued)

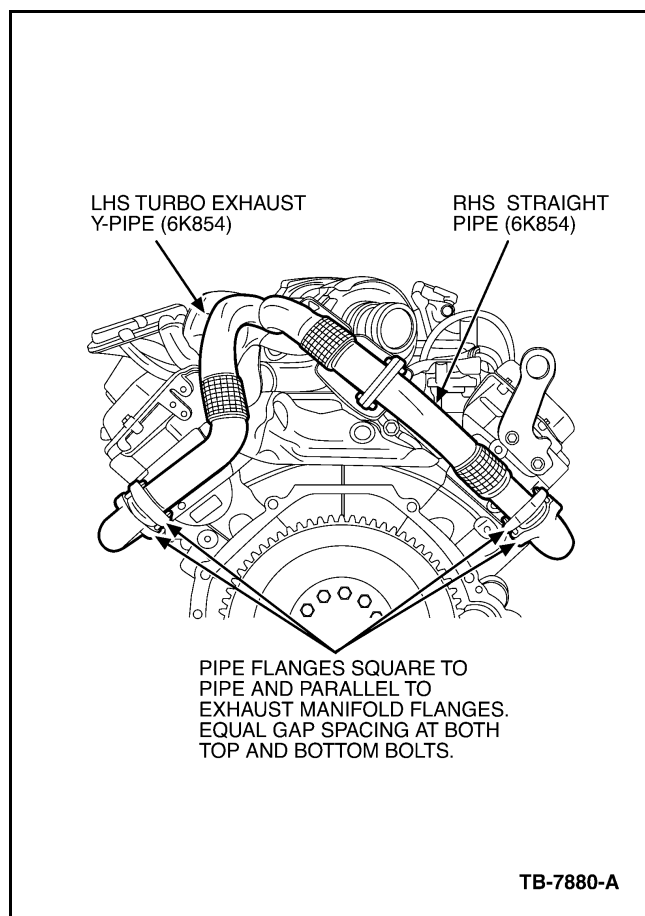
Figure 1 - Article 05-19-12

8. Final torque pedestal fasteners to 23 lb-ft (31 N•m).
9. Complete turbocharger installation, final torque turbo mounting fasteners per Workshop Manual Section 303 instructions.
10. Re-secure LHS Y-pipe V-band clamp at the turbo. Final torque to 9 lb-ft (12 N•m).
11. Check for good alignment and fit of the lower LHS Y-pipe and RHS straight-pipe flanges at the mating exhaust manifold outlets. Secure the LHS Y-pipe and RHS straight-pipe to the exhaust manifold outlets using M8 bolts (two (2) per side). Using hand tools snug fasteners evenly to position the pipe flanges square to the pipe and parallel to the exhaust manifold flanges. There should be an equal gap spacing between the pipe flange and exhaust manifold flange at both the top and bottom bolts (Figure 1).

12. Final torque LHS Y-pipe to RHS straight-pipe flat flange fasteners to 20 lb-ft (27 N•m).
13. Final torque LHS Y-pipe and RHS straight-pipe exhaust manifold flange fasteners to 20 lb-ft (27 N•m).
14. Re-secure exhaust down pipe V-band clamp and final torque to 89 lb-in (10 N•m).
15. After complete reassembly, road test vehicle to confirm no exhaust leaks and exhaust moan condition is resolved.
