FORD:
2003-2005 Excursion

2003-2007 F-Super Duty
2004-2008 E-350, E-450, E-550

This article supersedes TSB **08-23-8** to update the Service Procedure.

ISSUE

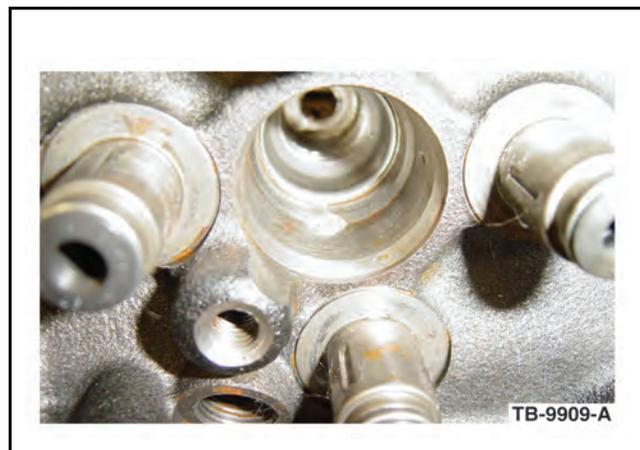
Figure 1 - Article 09-26-1

Some 2003-2007 F-Super Duty 250-750, 2003-2005 Excursion and 2004-2008 E-Series vehicles built on or before 9/30/2008 may exhibit fuel in engine coolant, due to leaks in the cylinder head fuel injector area. Symptoms may include fuel in engine coolant and coolant expulsion from the degas bottle.

6. Spray a 50/50 mixture of dish soap and water generously inside each injector bore. Ensure cylinder head injector bore casting is coated with a soap layer.
7. Inspect each injector bore for bubbles. A light and mirror or bore-scope may aid in pinpointing a leak location. Most common area is between the two injector fuel sealing O-rings in the sealing area on the side nearest the cylinder glow plug. (Figure 1)

- a. Replace cylinder head if leaking through casting. Refer to WSM, Section 303-01C.
- b. Flush cooling system, refer to other applicable service bulletins for proper cooling system flush procedures.
