# Technical Service Information

**TSI-05-12-07**

**Subject:** Low Injection Control Pressure (ICP) Test

Engine Family: International® VT 365 2004 MY Diesel Engines  
SN Range: 112360-Up

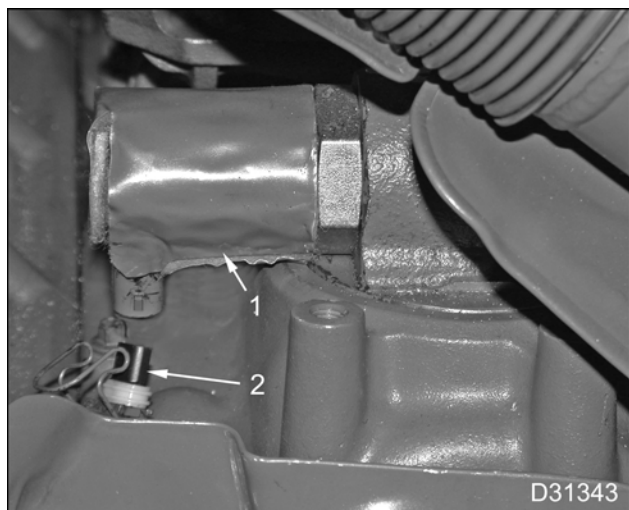
**Figure 2** IPR valve coil in weather protected position

1. IPR valve coil with heat shield
2. Engine harness connector

1. Disconnect engine wiring harness from IPR valve and inspect engine wiring harness connector and IPR valve terminal for corrosion. Inspect terminal for bent pins, or pushed back pins.

- If there is corrosion on either the IPR valve or the wiring harness connector for the IPR valve, replace both the IPR valve and wiring harness connector for the IPR valve. Retest ICP pressure.
- If the wiring harness connector and IPR valve are not corroded or damaged, continue with step 3.

**CAUTION:** If the IPR coil was rotated, return IPR valve to the weather protected position as shown above, after repairs are made

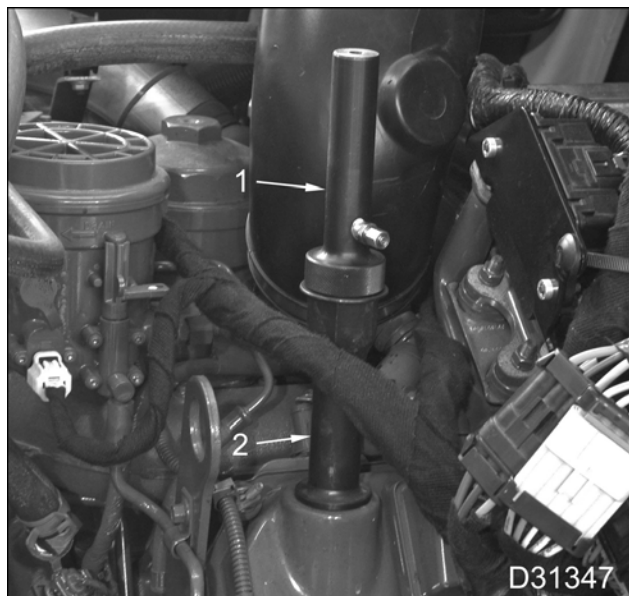
**Figure 5 Oil fill extension and Crankcase Pressure Test Adapter**

1. Crankcase Pressure Test Adapter
2. Oil fill extension (Part No. 1830971C91)

**NOTE:** The Crankcase Pressure Test Adapter or rubber hose will magnify the sound of an air leak.

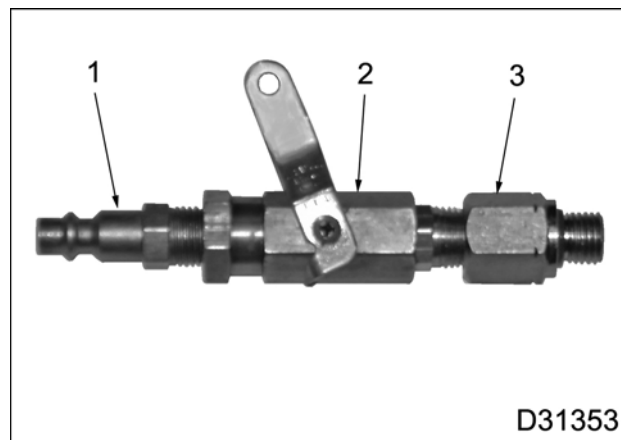
**Figure 7 ICP system test assembly**

1. Air chuck
2. Shutoff valve
3. ICP System Test Adapter

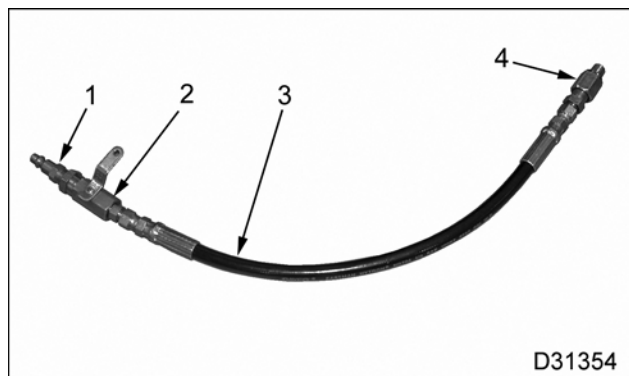
**Figure 8** ICP system test assembly with hose

1. Air chuck
  2. Shutoff valve
  3. Hose
  4. ICP System Test Adapter
5. Assemble ICP System Test Adapter to a shutoff valve and an air chuck.

**NOTE:** Depending on chassis application, a hose may be used to provide easier access for a compressed air supply.

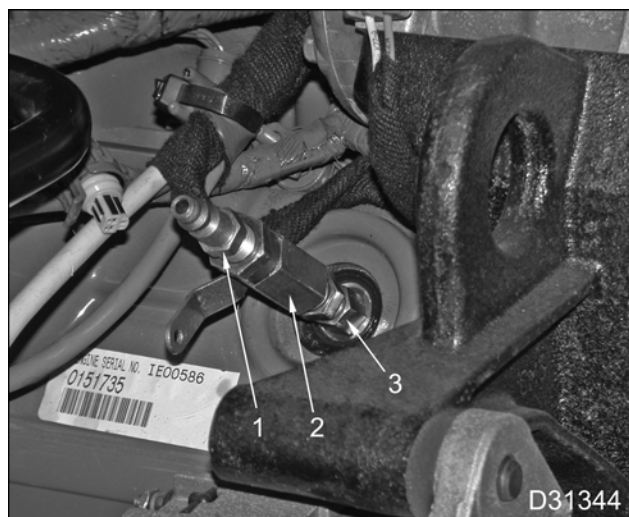
**Figure 9** ICP system test assembly

1. Air chuck
  2. Shutoff valve
  3. ICP System Test Adapter
6. Install ICP system test assembly. (ICP System Test Adapter, shutoff valve, and air chuck)

7. Connect the compressed air supply line to air chuck.
8. Apply 689 kPa (100 psi) of pressure and open shutoff valve. Use Crankcase Pressure Test Adapter or hose to listen for an air leak.

**NOTE:** When air pressure is first applied, it may take up to 5 minutes before an air leak can be heard. This allows air pressure to displace the engine oil in the ICP system. Once engine oil is displaced, an air leak can be heard almost immediately.

- A faint air leak should be heard. Air should be passing through the IPR valve and returning to the crankcase when the IPR valve is not energized.

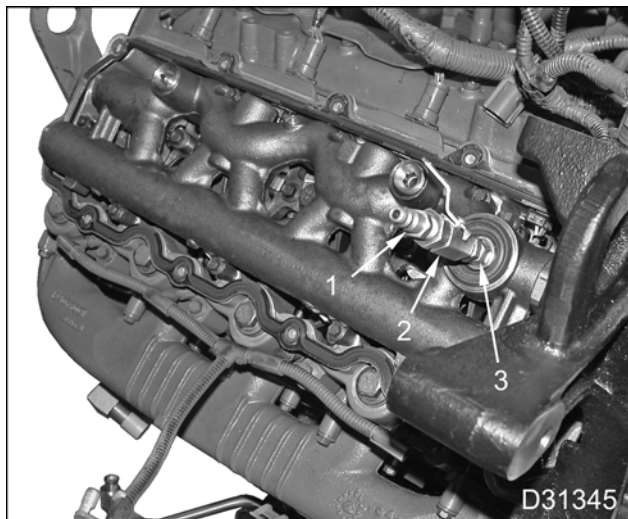
**Figure 10** Compressed air supply with valve cover off

1. Air chuck
2. Shutoff valve
3. ICP System Test Adapter

5. Connect the compressed air supply line to air chuck.
6. Apply 689 kPa (100 psi) of pressure and open shutoff valve. Use Crankcase Pressure Test Adapter or hose to listen for an air leak.
  - A faint air leak should be heard. Air should be passing through the IPR valve and returning to the crankcase when the IPR valve is not energized.
7. Use the Actuator Breakout Harness to apply B+ and ground to the IPR valve.

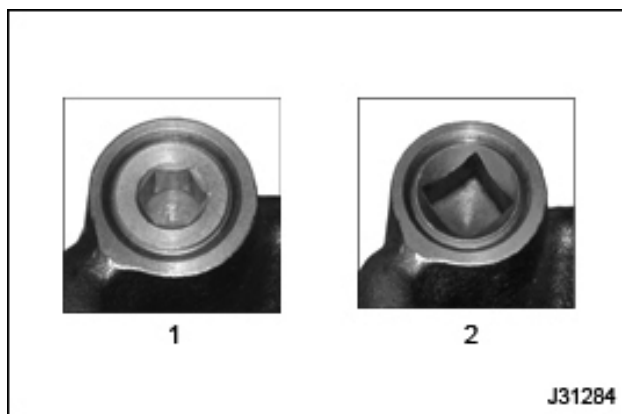
**Figure 11 Socket heads for long and short crankcase-to-head tube plugs**

1. Hex head socket (Long crankcase-to-head tube plugs and common rail port plugs)
2. Square head socket (Short crankcase-to-head tube plugs and common rail port plugs)

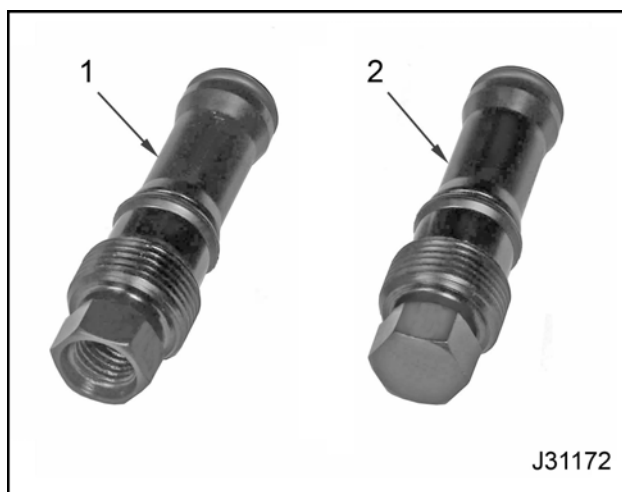
**Figure 12 ICP Adapter/Plug Kit (Short)**

1. ICP Sensor Adapter (Threaded hex head)
2. ICP Leak Test Plug (Solid hex head)

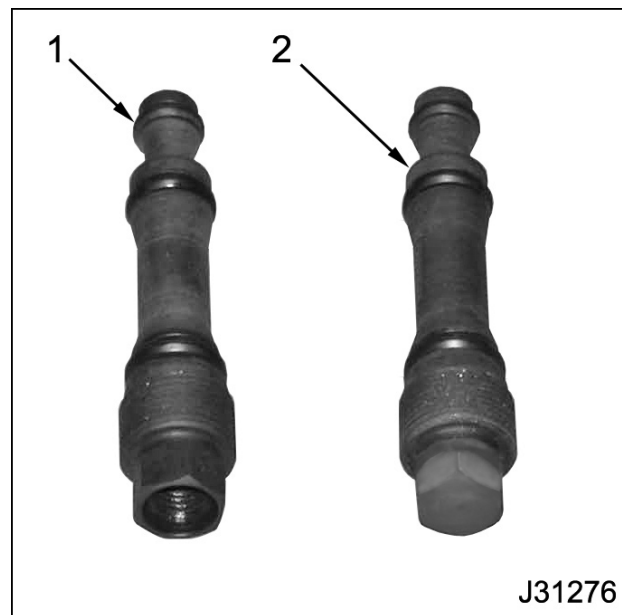
**Figure 13 ICP Adapter/Plug Kit (Long)**

1. ICP Sensor Adapter (Threaded hex head)
2. ICP Leak Test Plug (Solid hex head)

**CAUTION:** To avoid damage to the engine, make sure the crankcase-to-head tube plug (long or short) is installed with the correct crankcase-to-head tube.

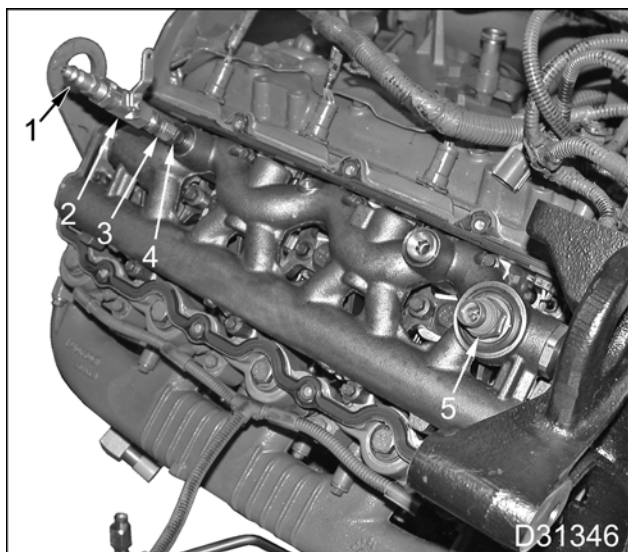
**Figure 14 ICP system test assembly and ICP Sensor Adapter (Right cylinder head)**

1. Air chuck
2. Shutoff valve
3. ICP System Test Adapter
4. ICP Sensor Adapter
5. ICP sensor

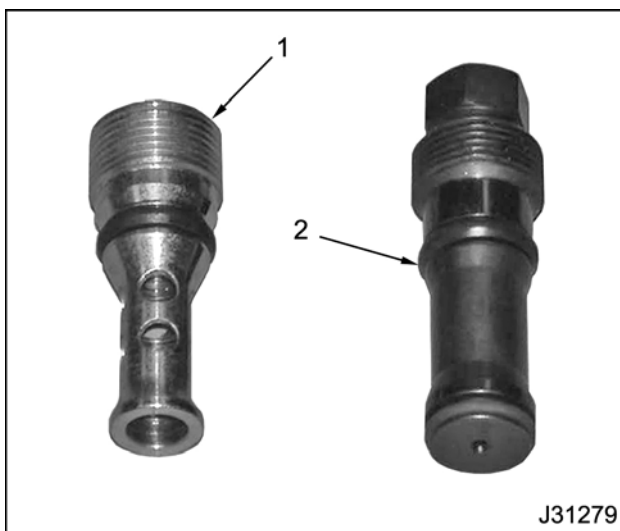
**Figure 15 Crankcase-to-head tube plug (Short) and ICP Leak Test Plug (Short)**

1. Crankcase-to-head tube plug
2. ICP Leak Test Plug (Solid hex head)

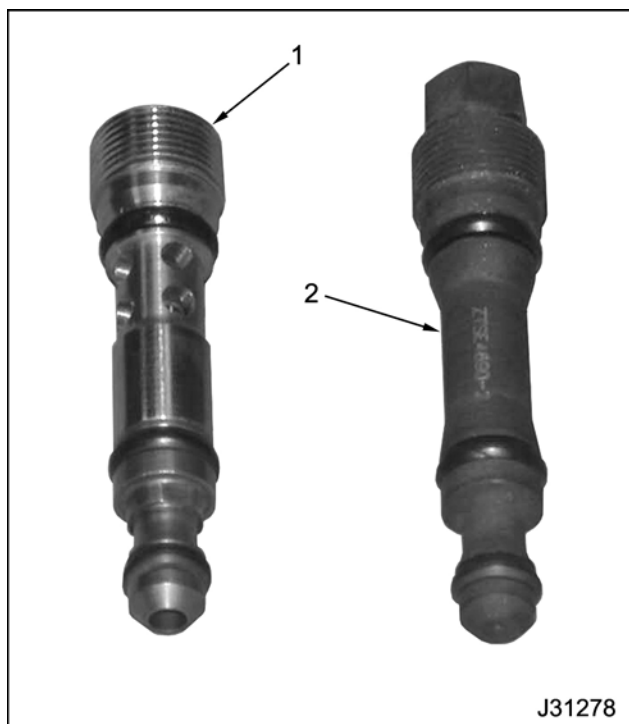
**Figure 16 Crankcase-to-head tube plug (Long) and ICP leak test plug (Long)**

1. Crankcase-to-head tube plug
2. ICP Leak Test Plug (Solid hex head)

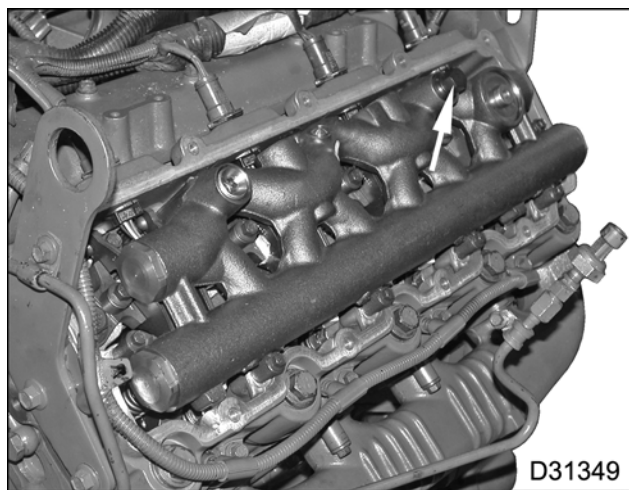
**Figure 17 ICP leak test plug (Long)**

1. ICP Leak Test Plug (Solid hex head)
13. Remove the crankcase-to-head tube plug from the rear of the left side oil rail. Install the ICP Leak Test Plug in this port.

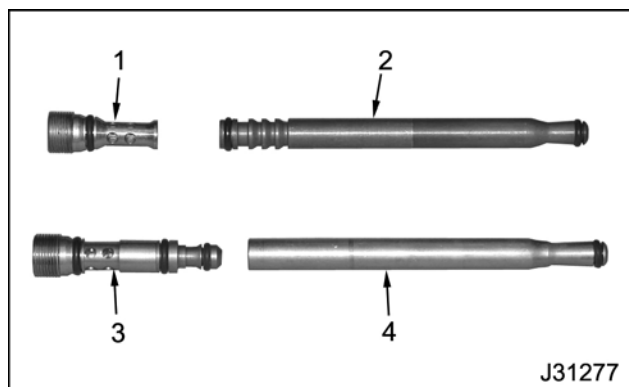
**Figure 18 Crankcase-to-head tubes**

1. Crankcase-to-head tube plug (Short)
2. Crankcase-to-head tube (Used with short rail plug)
3. Crankcase-to-head tube plug (Long)
4. Crankcase-to-head tube (Used with long rail plug)

19. Remove the questionable crankcase-to-head tube or tubes from the engine and inspect D-rings. Follow the procedures in the *Engine Service Manual*.

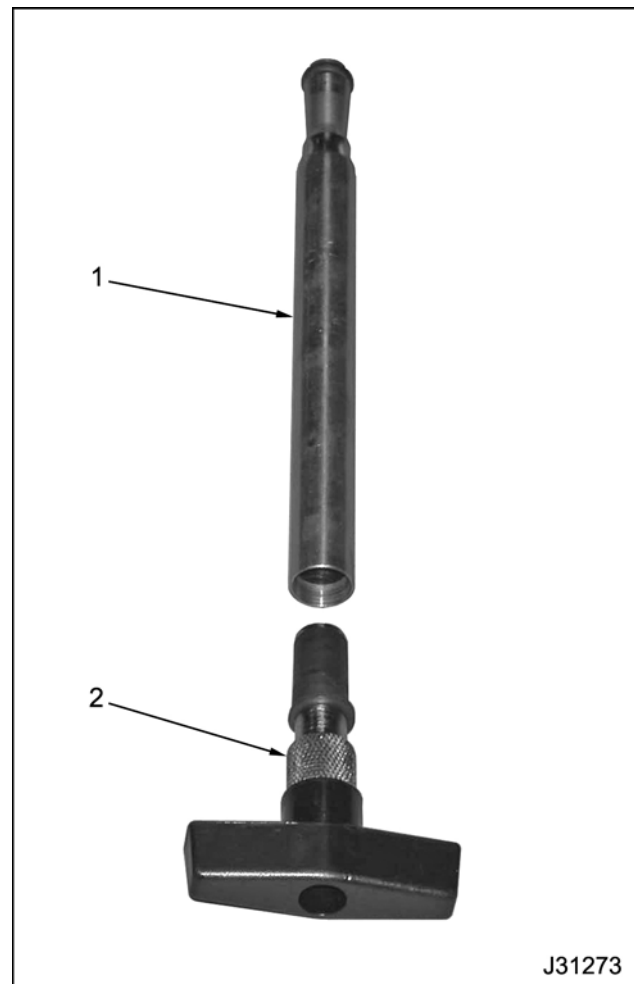
**Figure 19 Crankcase-to-head tube and crankcase-to-head Tube Removal Tool**

1. Crankcase-to-head tube
2. Crankcase-to-head Tube Removal Tool

**NOTE:** If crankcase-to-head tube is not attached to the leak test plug or sensor adapter, use ZTSE4694 crankcase-to-head tube removal tool to remove tube from crankcase.

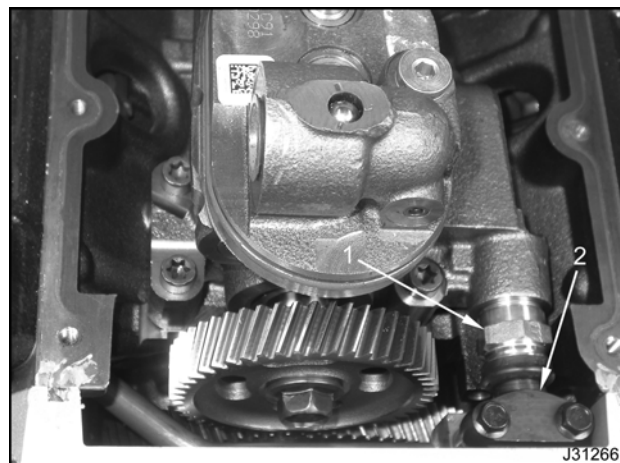
Figure 21 Possible leak areas in branch tube connection to the discharge port of high-pressure pump

1. Quick disconnect
2. Branch Tube Adapter

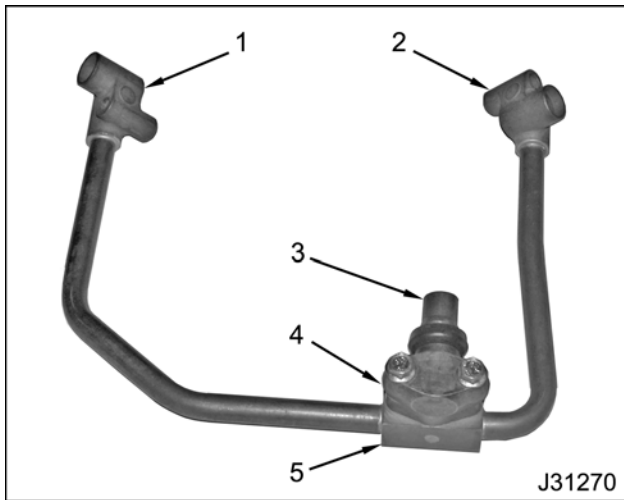
**Figure 22 Possible leak areas in Branch Tube Assembly**

1. Left branch tube block
  2. Right branch tube block
  3. Quick disconnect
  4. Branch Tube Adapter
  5. Center branch tube block
25. Check for air leaks in the Branch Tube Assembly connection to the discharge port of high-pressure pump and the Branch Tube Adapter.

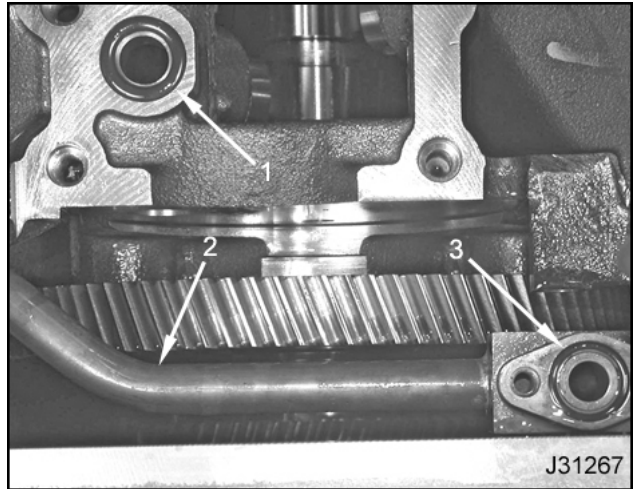
**Figure 23 Possible leak areas under high-pressure pump**

1. O-ring for high-pressure oil pump inlet
  2. Branch Tube Assembly
  3. O-ring for Branch Tube Adapter
26. Listen for air leaks in both O-ring areas under the high-pressure pump,
- If an air leak is not detected in the area under the high-pressure cover, but an air leak is heard, replace the Branch Tube Assembly.
  - If an air leak is located or detected, repair or replace as required.

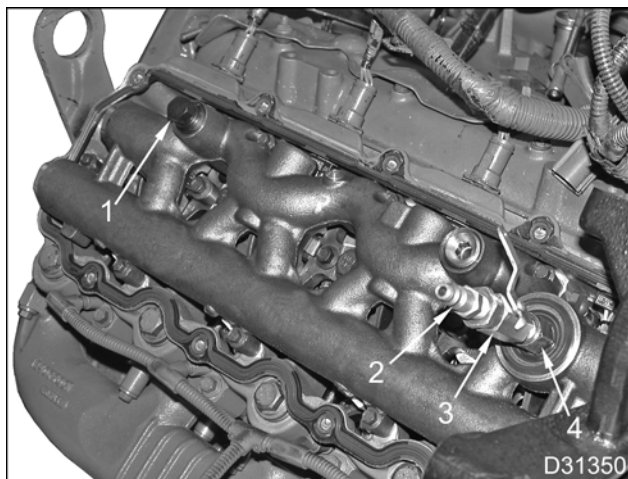
**Figure 24 ICP Leak Test Plug and ICP System Test Adapter (Right cylinder head)**

1. ICP Leak Test Plug
2. Air chuck
3. Shutoff valve
4. ICP System Test Adapter

1. Remove the crankcase-to-head tube plug from the rear of the oil rail. Install the ICP Leak Test Plug in this port.

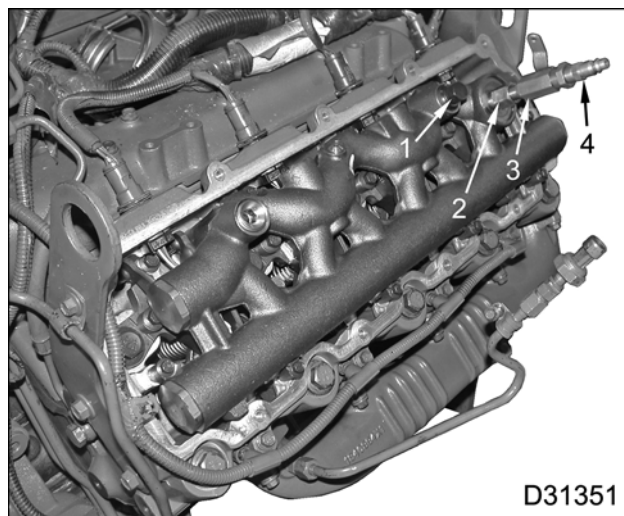
**Figure 25 ICP Leak Test Plug and ICP System Test Adapter (Left cylinder head)**

1. ICP Leak Test Plug
2. ICP System Test Adapter
3. Shutoff valve
4. Air chuck

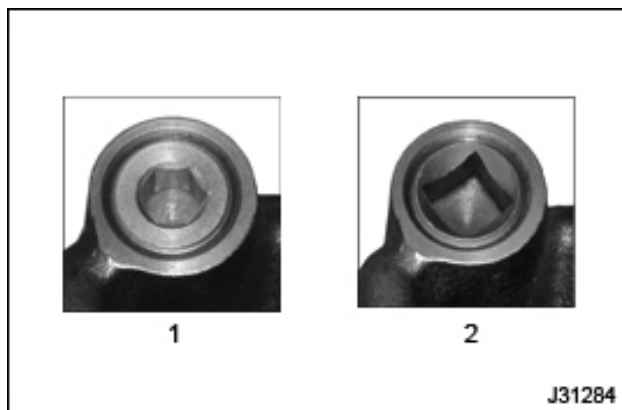
**Figure 26 Crankcase-to-head tube plugs**

1. New (hex head) long crankcase-to-head tube plug
2. Old (square head) short crankcase-to-head tube plug

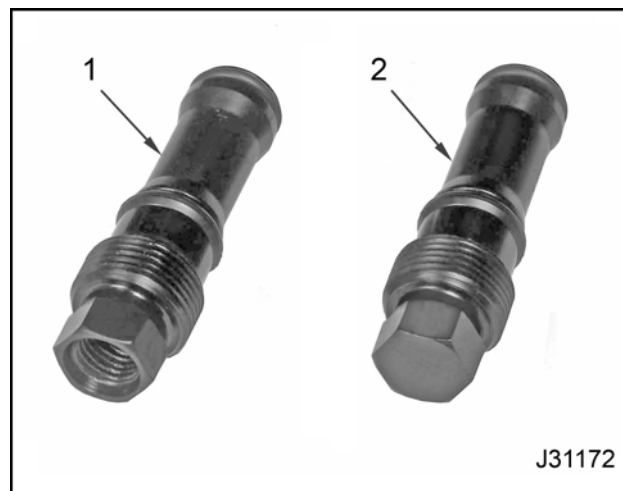
**Figure 27 ICP sensor adapter and ICP leak test plug**

1. ICP sensor adapter (threaded hex head).
2. ICP leak test plug (solid hex head).

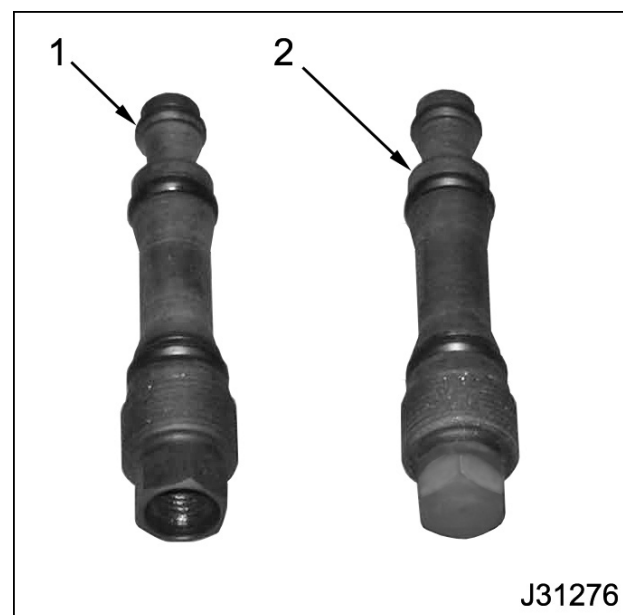
**Figure 28 ICP Adapter/Plug Kit**

1. ICP Sensor Adapter (Threaded hex head)
2. ICP Leak Test Plug (Solid hex head)

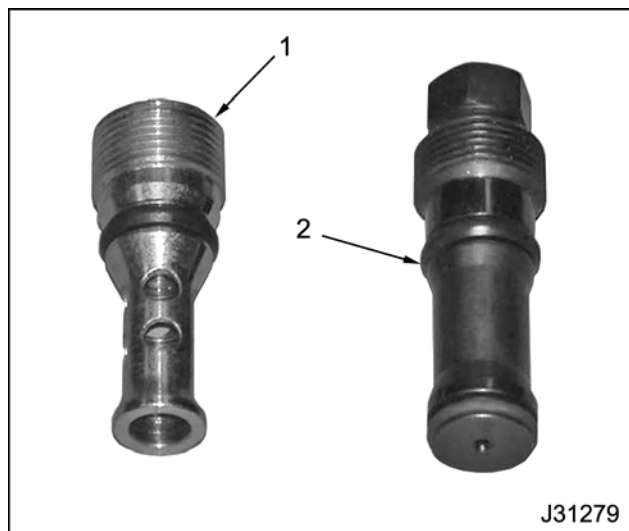
**Figure 29 Crankcase-to-head tube plug and ICP Leak Test Plug**

1. Crankcase-to-head tube plug
2. ICP Leak Test Plug (Solid hex head)

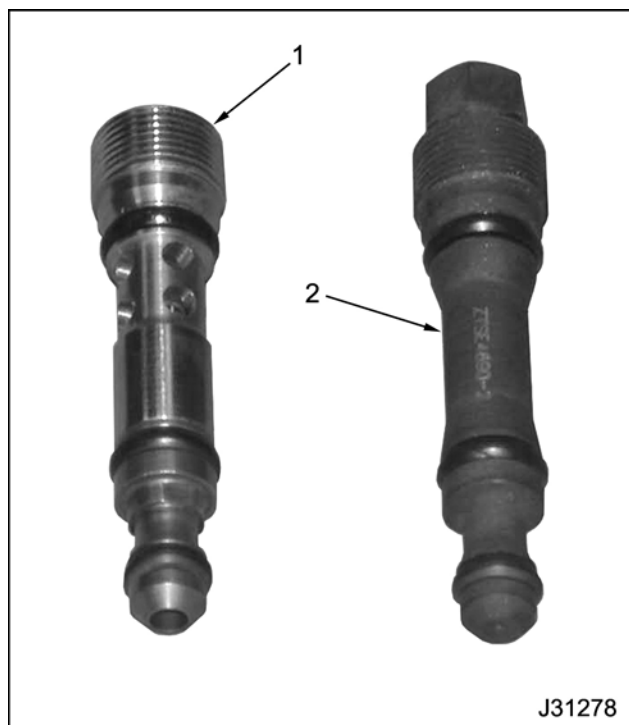
**Figure 30 Crankcase-to-head tube plug and ICP Leak Test Plug**

1. Crankcase-to-head tube plug
2. ICP Leak Test Plug

**CAUTION:** To avoid damage to the engine, make sure the crankcase-to-head tube plug (long or short) is installed with the correct crankcase-to-head tube.

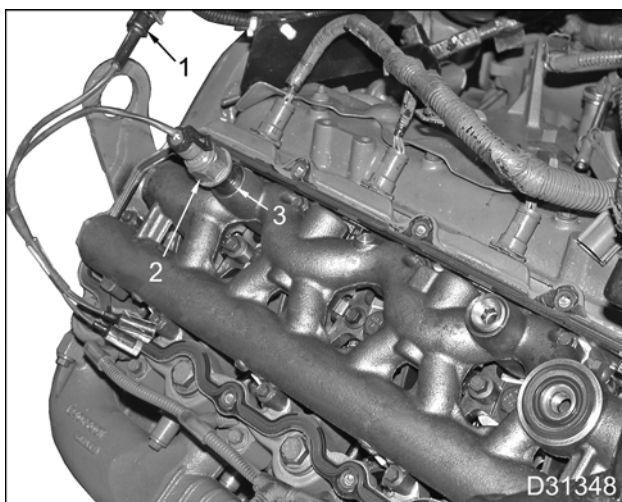
**Figure 31 ICP sensor with ICP Sensor Adapter (Right cylinder head)**

1. Pressure Sensor Breakout Harness
2. ICP sensor
3. ICP Sensor Adapter

5. Install ICP sensor into ICP Sensor Adapter.
6. Connect the engine wiring harness to the ICP sensor. Use the Pressure Sensor Breakout Harness as an extension, if needed.

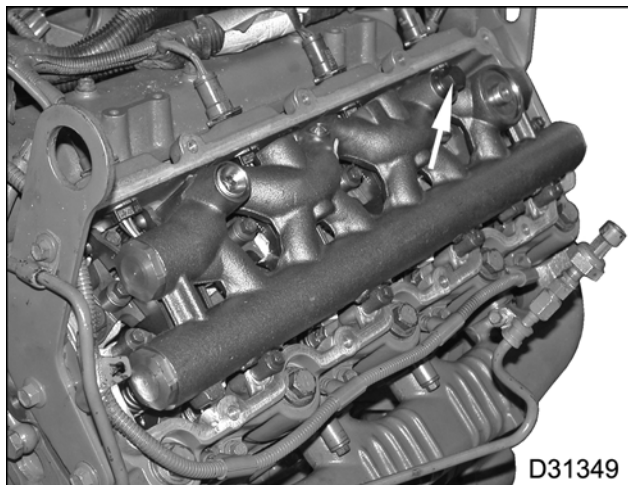
**Figure 32** ICP Leak Test Plug (Left cylinder head)

7. Remove the crankcase-to-head tube plug from the rear of the left side oil rail. Install the ICP Leak Test Plug in this port.

- This will block oil flow to the left oil rail and injectors.
- When crankcase-to-head tube plug is removed, the crankcase-to-head tube may still be attached. Remove tube from plug. Install tube to leak test plug for testing.
